# PREMIER MATERIALS GROUP COOLIDGE MINE RECLAMATION PLAN

Axelrod, Inc.  
P.O. Box 14401  
Scottsdale, Arizona 85267

Project No. 22700  
Rev 2: August 2023

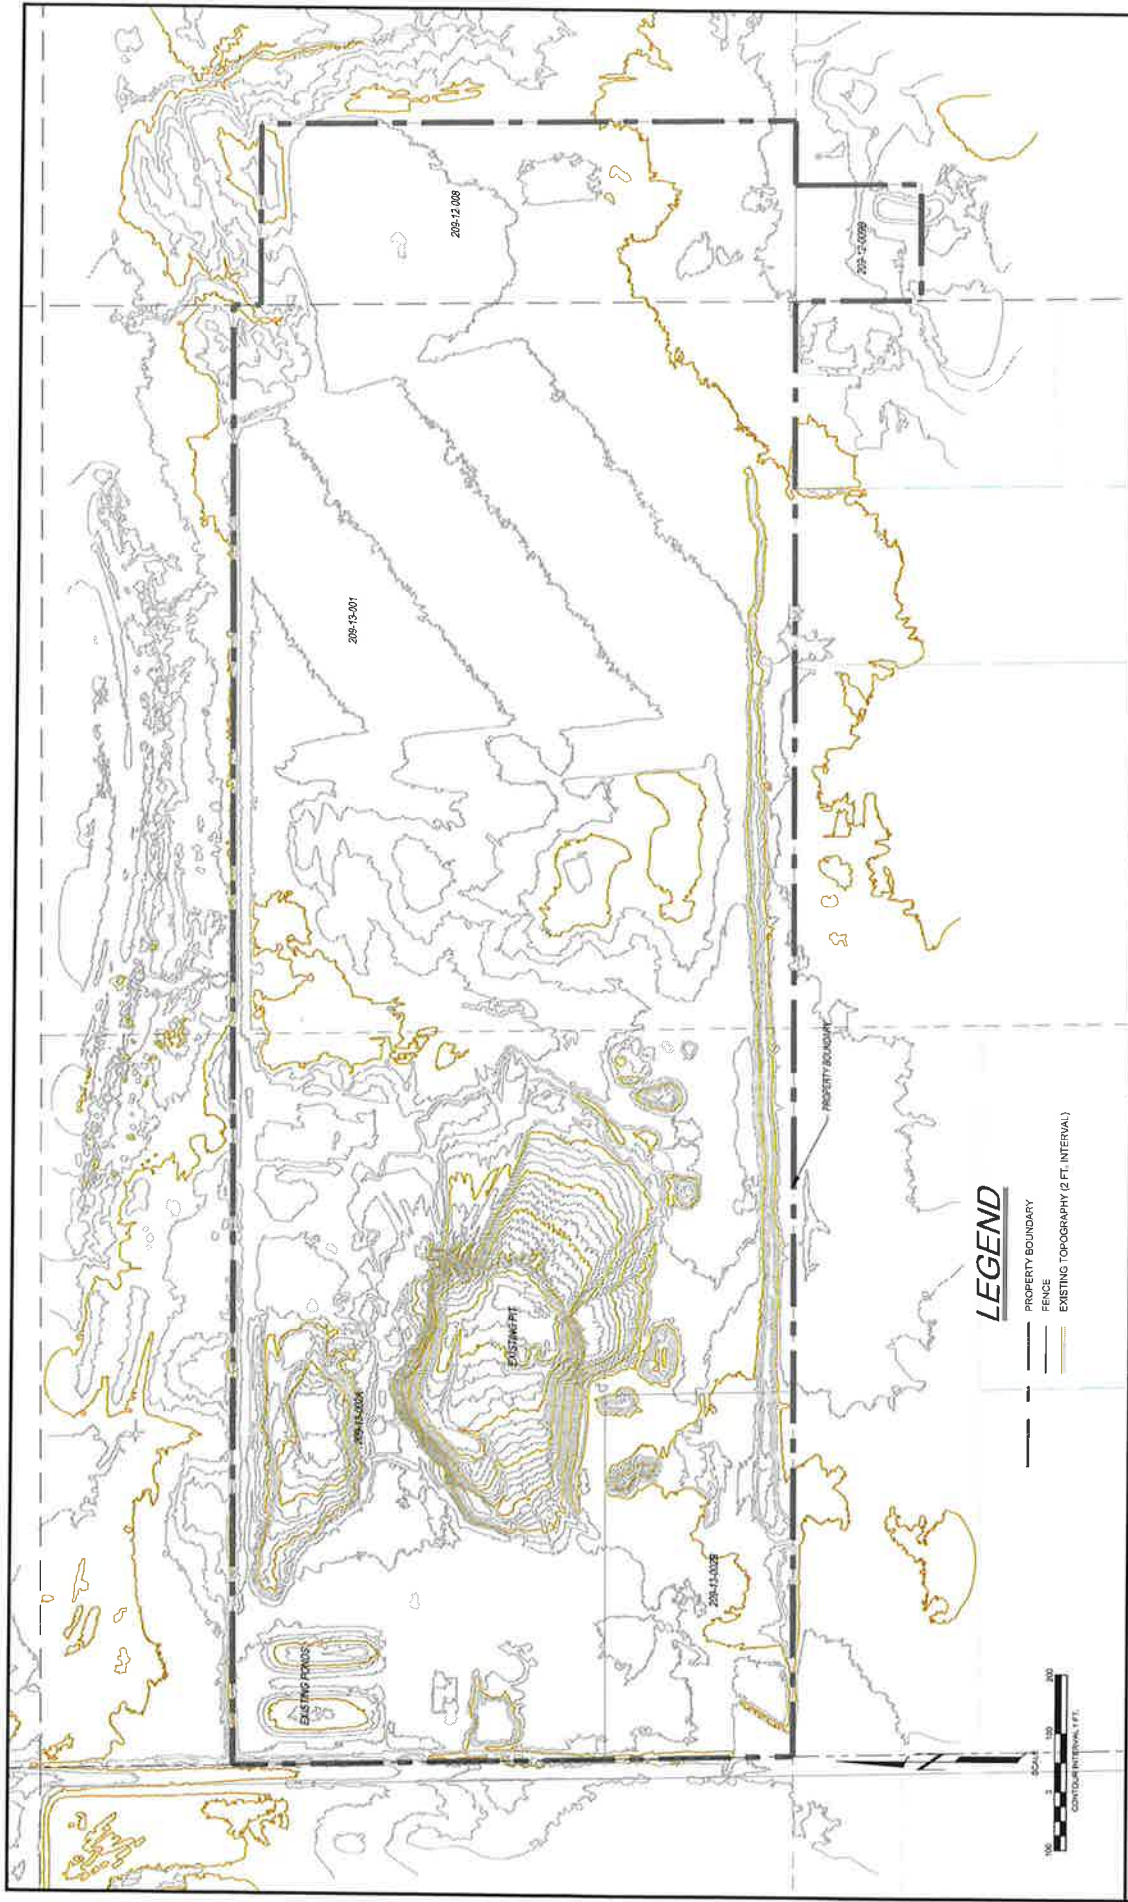
PROJECT: <b>MINE RECLAMATION PLAN</b> JANUARY 2023	TITLE: <b>SITE PLAN</b> NOVEMBER 2022	PREPARED BY: <b>AXELROD INC.</b> <small>PHOENIX, ARIZONA</small>	PREPARED FOR: <b>COOLIDGE MINE</b>	SCALE: AS SHOWN	DATE: 11/02/22	REGION:
				FIGURE No. <b>2</b>

- PROPERTY BOUNDARY
- FENCE
- EXISTING TOPOGRAPHY (2 FT. INTERVAL)

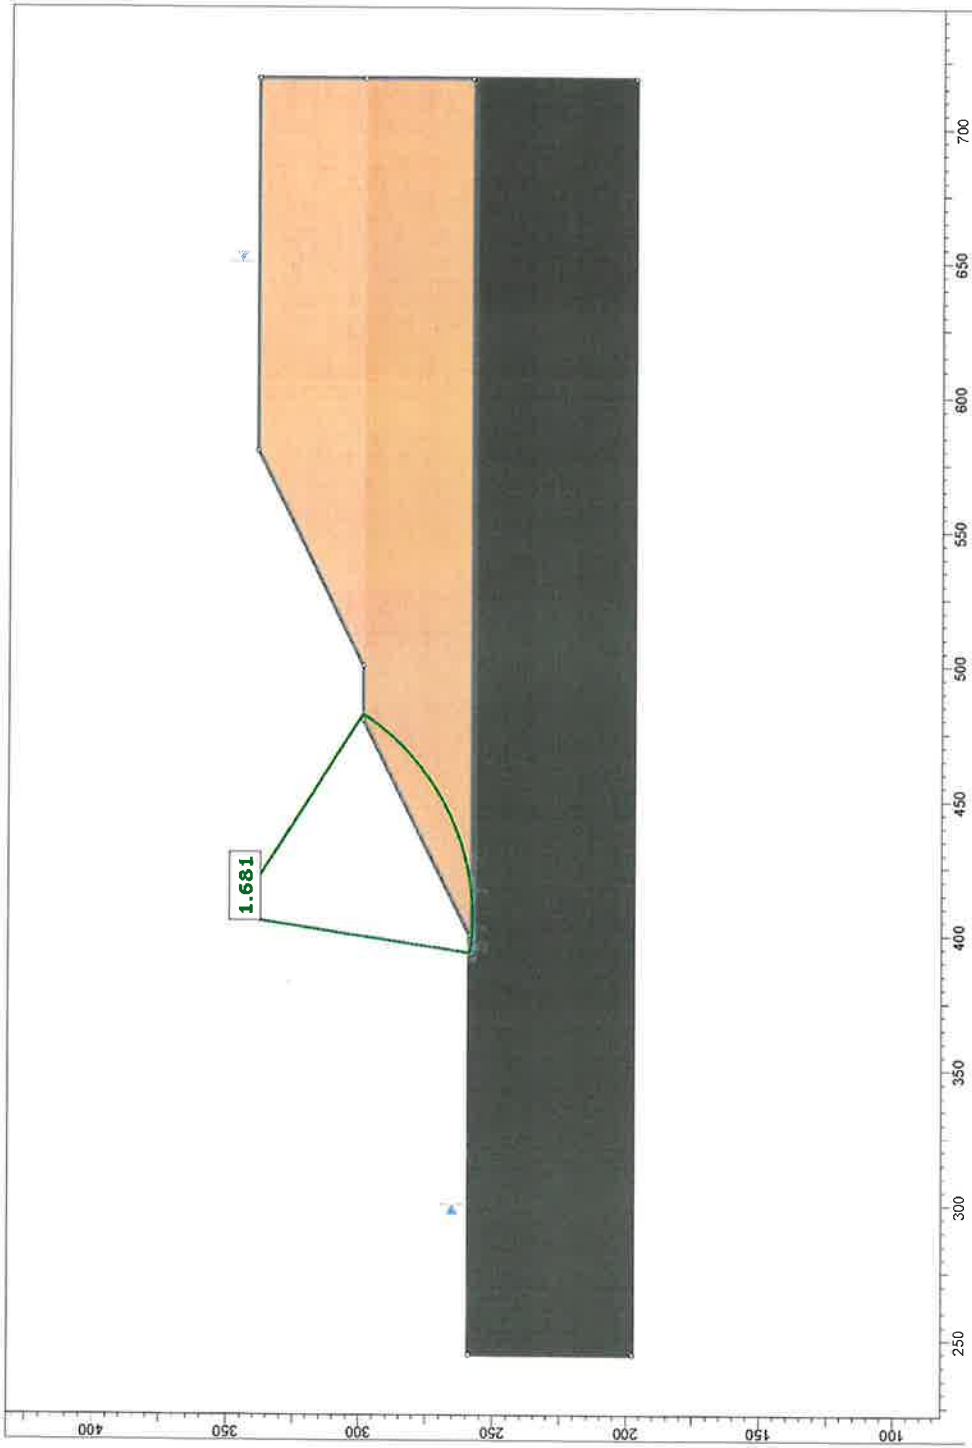
Figure 5 - Ultimate Pit - Circle, Static

The analysis for this report was conducted for the pit slope at full height stage. The stability analysis results are shown on Figure 5 and summarized in the table below.

Acceptable factors of safety were estimated for the proposed slope grade of 2H:1V. The factor of safety was 1.68 which is greater than 1.5, the normally accepted minimum for static conditions. The slope stability evaluation is presented in more detail in Appendix A.
