**RECLAMATION AND CLOSURE
PLAN**

**ARCOSA AGGREGATES WEST
GLENDALE SITE**

S12, T2N, R1W – Maricopa County, Arizona

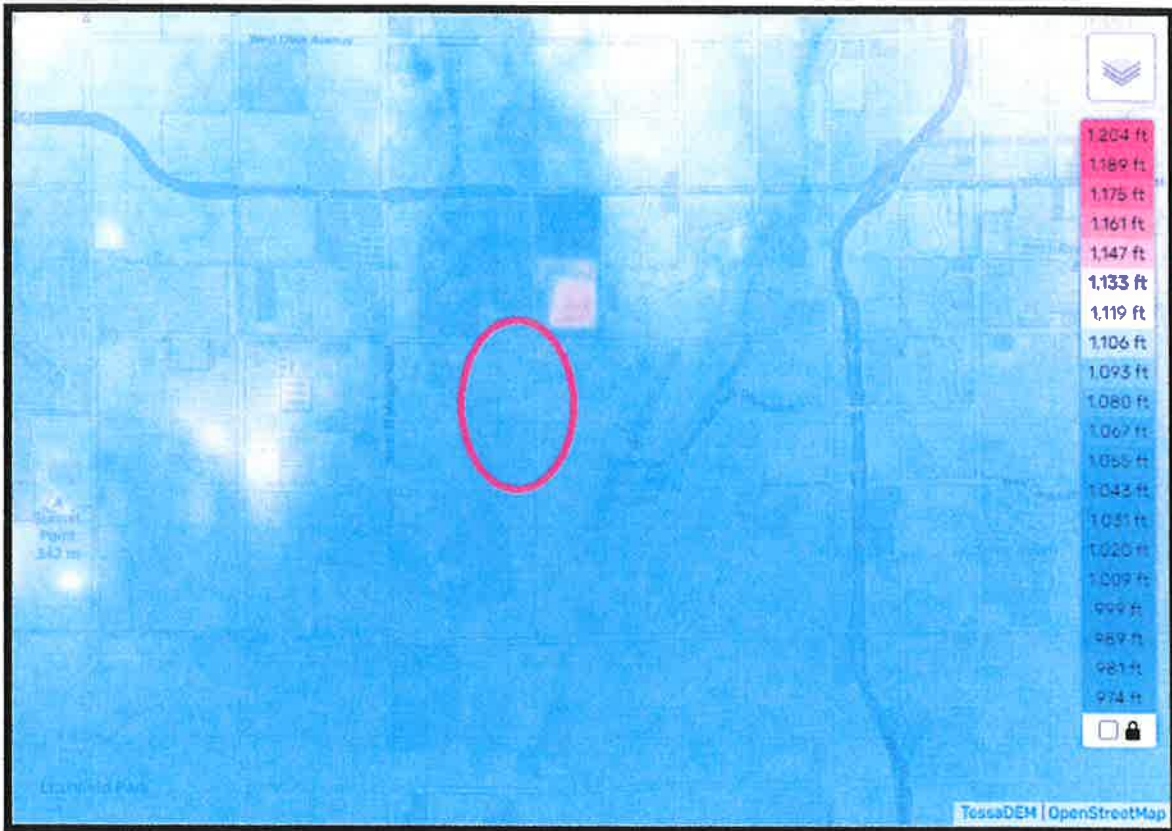
Map 3

Topographical Map

Dirt 101 Investment, LLC. Northern Site
Mean Elevation:
1,046 Feet

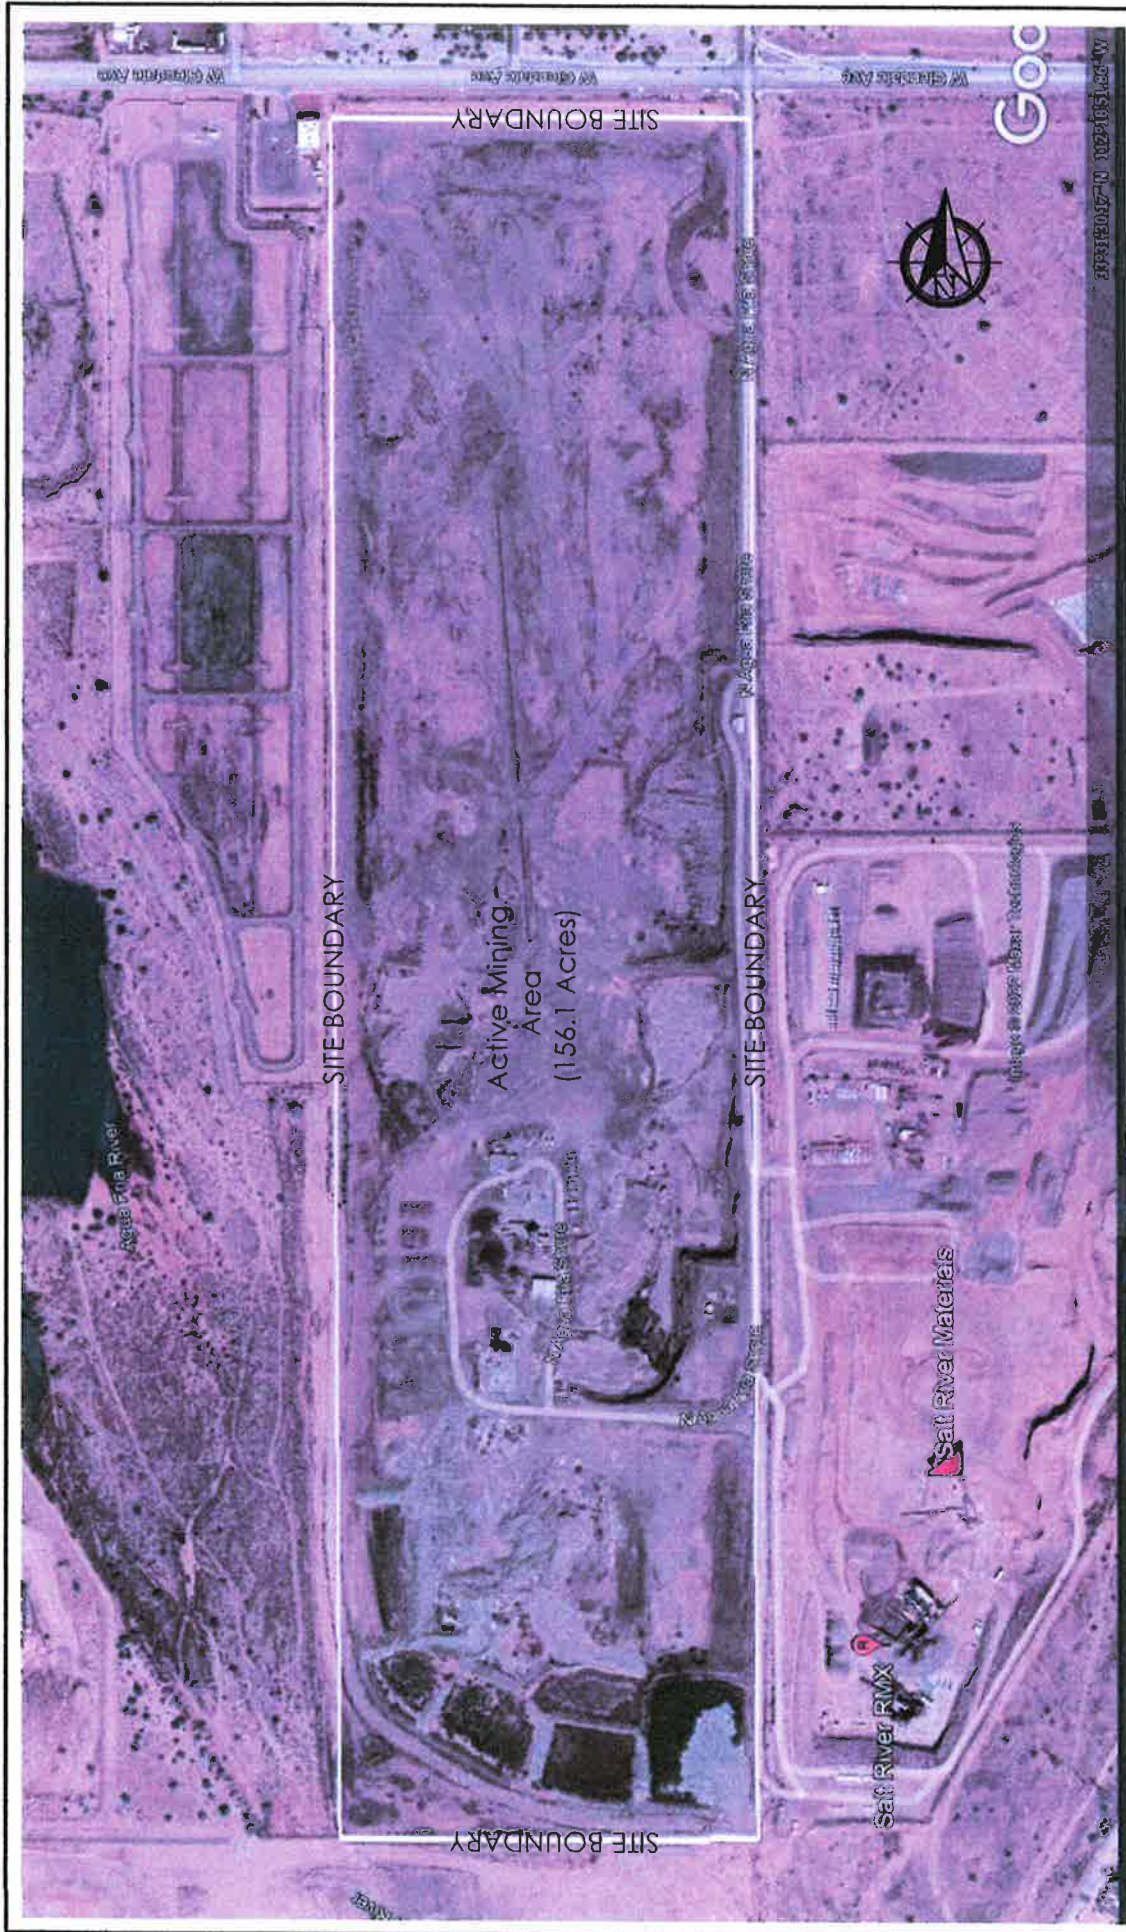
Map 4

Site Plan

SITE: Arcosa Aggregates West's Glendale Site	DRAWING NO. 4	PROJECT NO. 1	DATE. 11/1/22
---	------------------	------------------	------------------

TITLE: Figure 4 - Site Plan	SCALE.

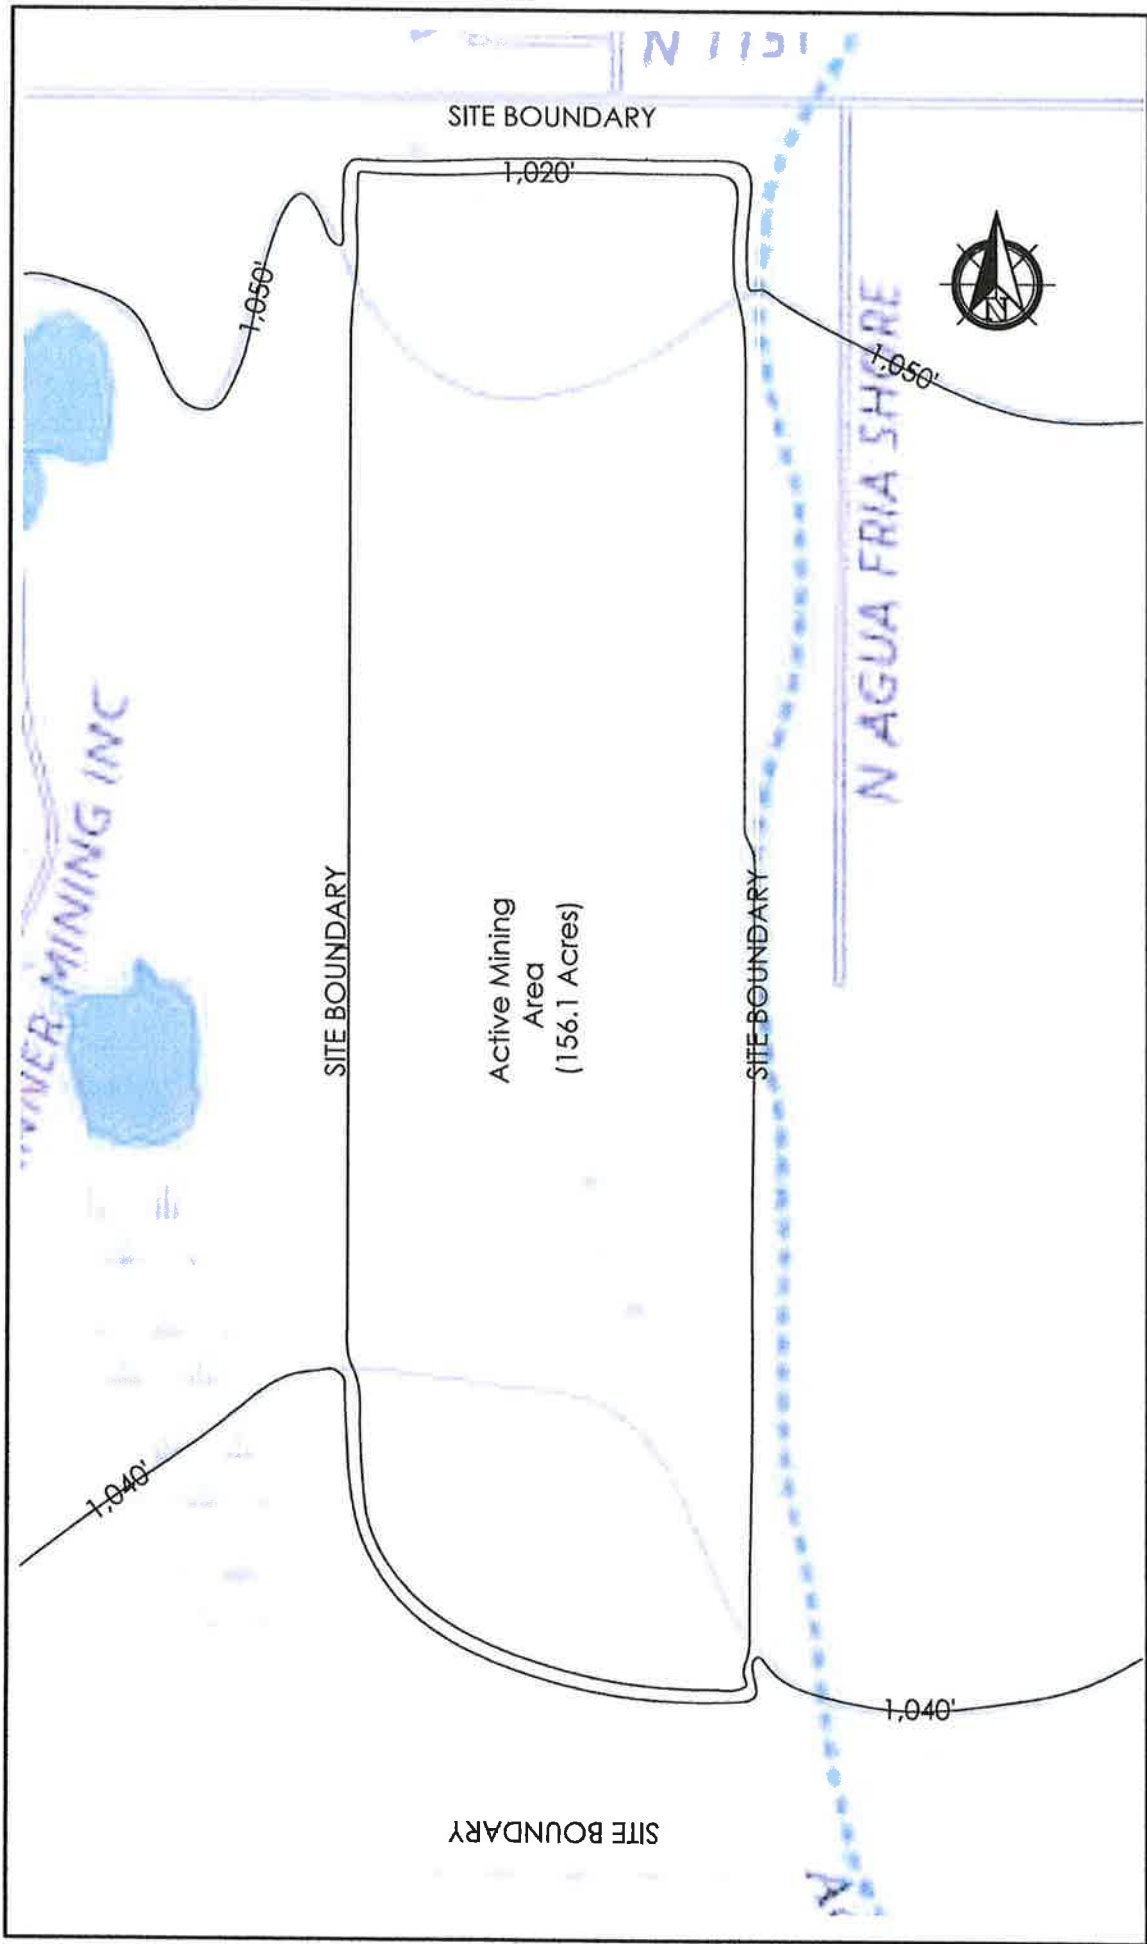
Map 5

Existing Topography

SITE: Arcosa Aggregates West's Glendale Site	DRAWING NO. 5	PROJECT NO. 1	DATE 11/1/22
TITLE: Figure 5 - Existing Topographic Map	SCALE SCALE: 1" = 600'	DRAWN JP	REVISION JP

Existing topography of the mining area can be found in Appendixes, Map 5. Currently, mining operations are taking place within the north 76.4 acres of the site. In the northern, western and southern portions of the site, the pit walls are sloped to 2H:1V, which is the angle of repose for material characteristic of the Agua Fria Wash. In the eastern portion of the site, the pit wall is only sloped in a few areas. There remains 2,375 ft. of pit wall that needs to be sloped. The material that will be utilized to slope the pit walls will come from stockpiles, fines piles, ponds and material that has yet to be mined (cut and fill techniques). Taking into consideration an aggregation of the current pit footage that has yet to be properly sloped (2,375 ft.) and an eventual pit depth (20-30 ft. from base elevation of 1,046 ft.), along with using a common fill dirt calculator, it is determined that 79,193 cu yd. of material needs to be utilized for sloping. Since the ponds in the southern portion of the site will need to be reclaimed with a dozer as well, it is determined that 483,629 cu yd. of material will need to be moved for disbursement. Coupling the sloping material (79,193 cu yd.) with the pond material disbursement (483,629 cu yd.), 562,822 cu yd. of material will need to be moved. Dispersion of the stock and fines piles into the pits for wall reclamation have been included in the cost estimates.

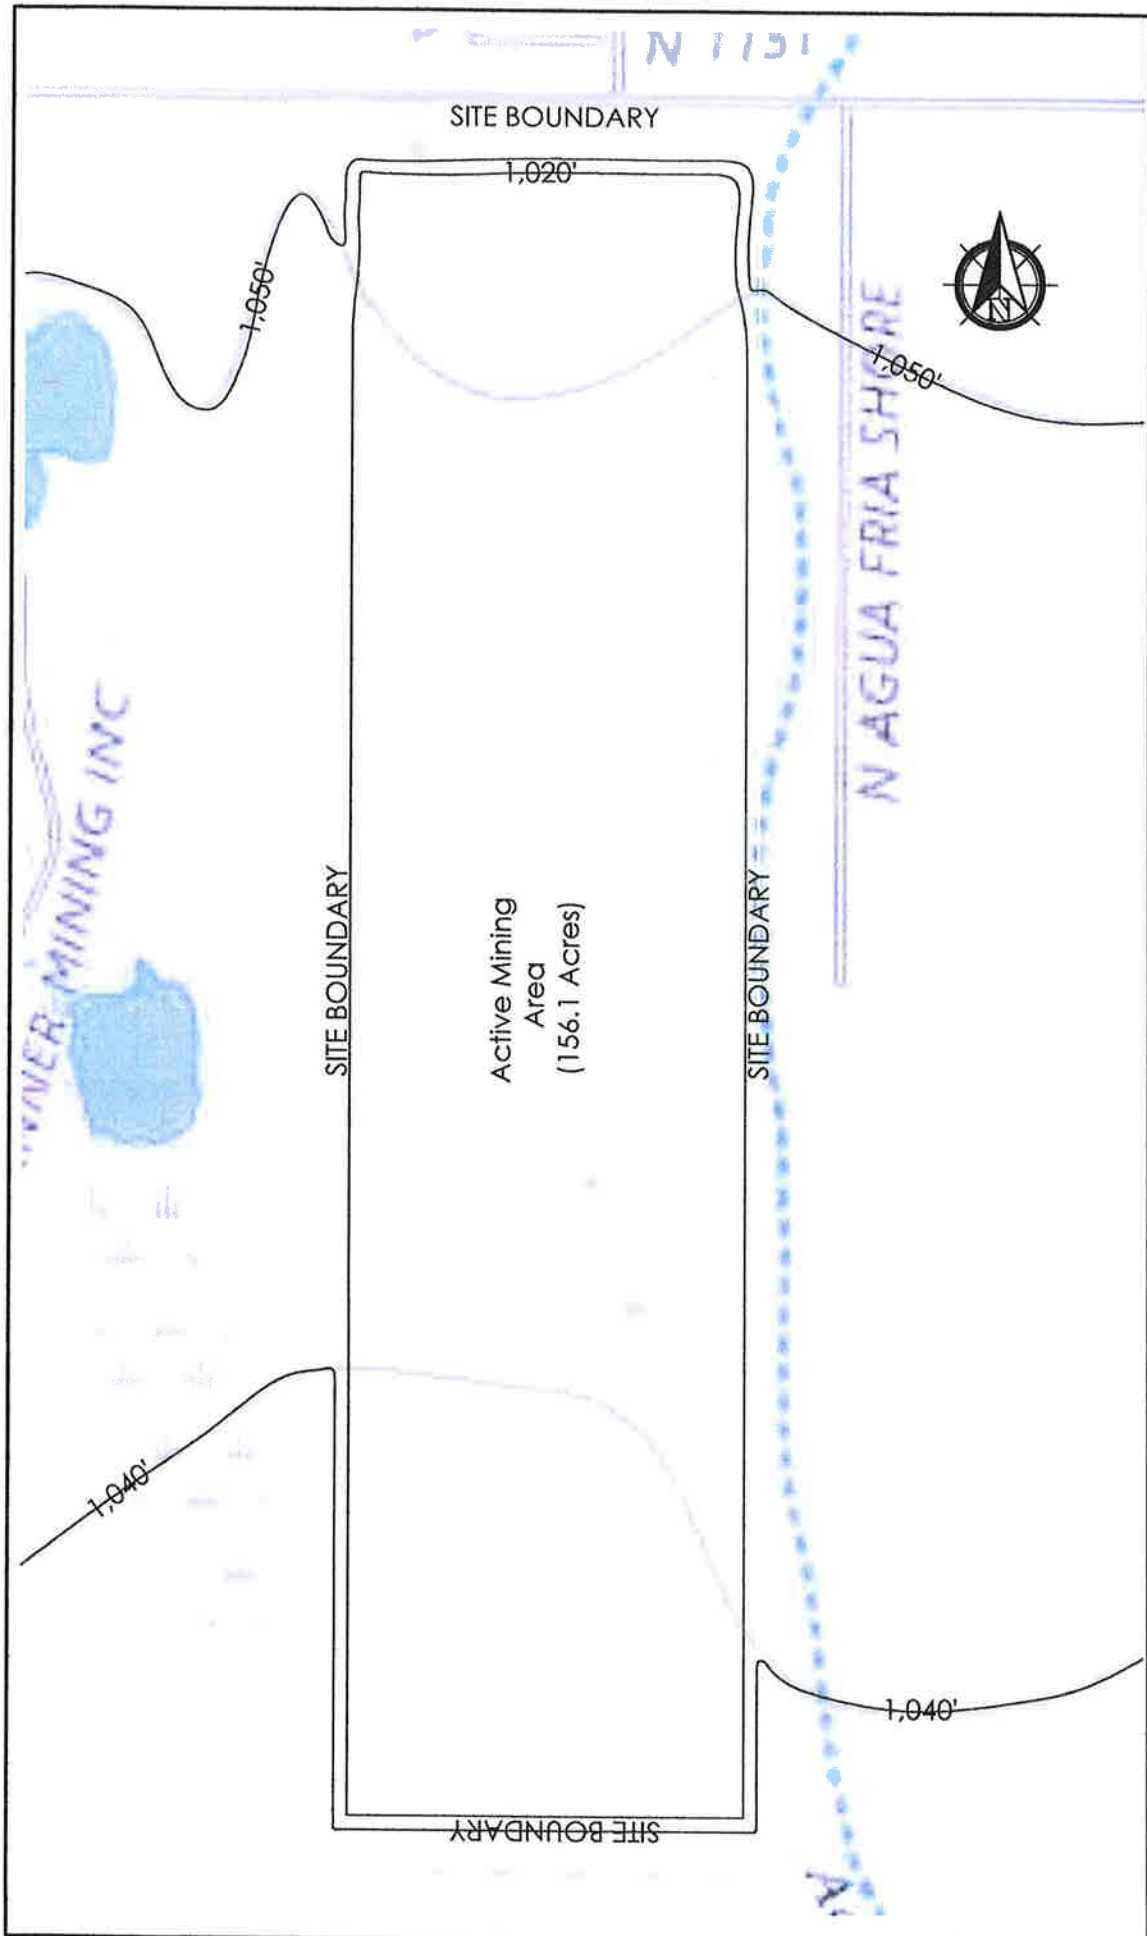
Final Reclamation Topography

SITE: Arcosa Aggregates West's Glendale Site	DRAWING NO. 6	PROJECT NO. 1	DATE 11/1/22
TITLE: Figure 6 - Final Reclamation Topography	SCALE: 1" = 600'

Proposed topography of the disturbed pit area can be found in Appendixes, Map 6.

The final contours and topography will take into account current storm water management plans, which include natural drainage channels, to maintain flood and erosion control. Consult Map 6 in Appendixes for final reclamation topography.
